# Home Inspection Report

227 33rd Street

Lindenhurst, NY 11757

Inspected On Fri, May 5, 2023 at 7:15 AM

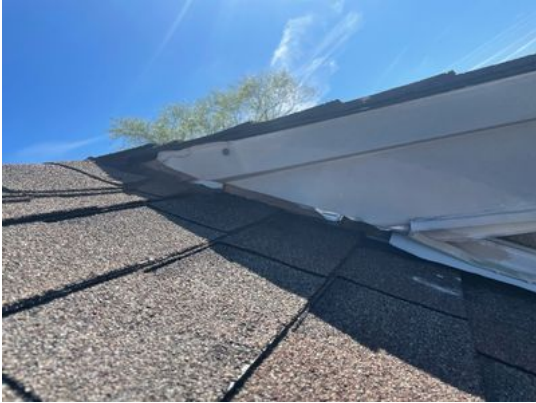
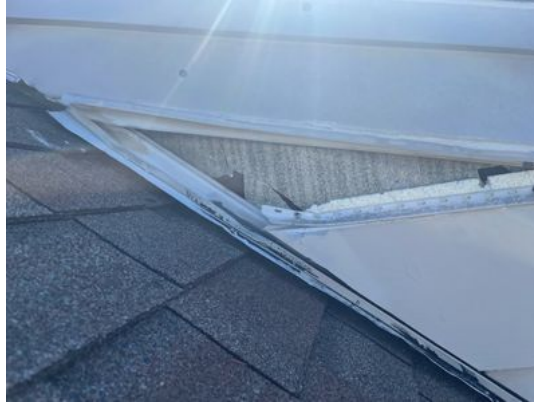
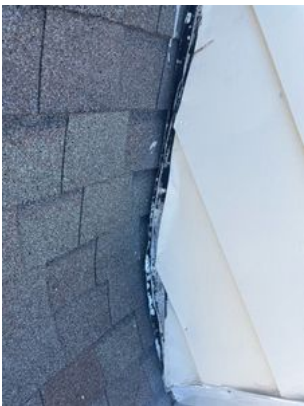
Siding and flashing repair needed on west peak

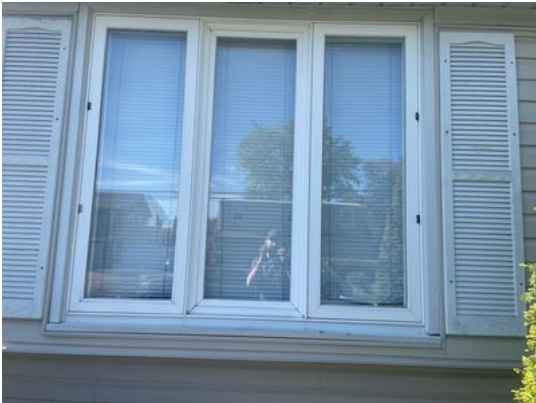
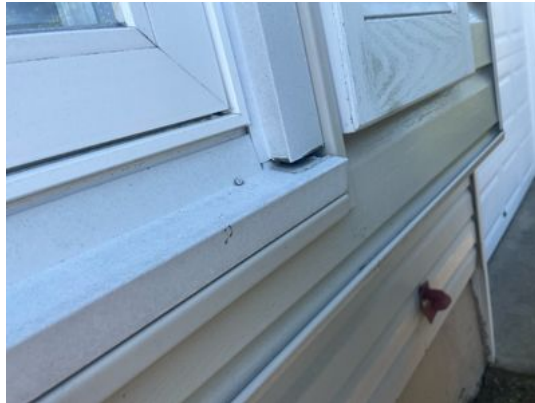
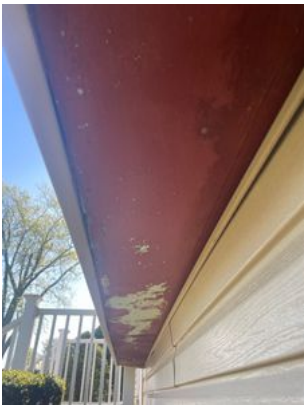
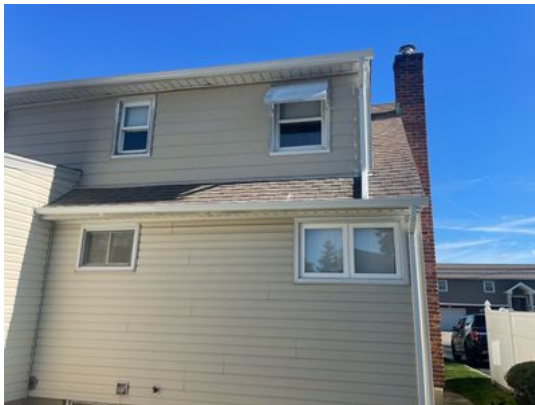
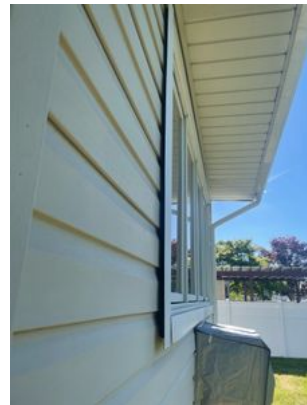
All window appear operable but in need of screens for child Safety, exterior damage visible on basement windows, upstairs unfinished bathroom window, kitchen south facing window, and north facing livingroom window, trim pulling away in spots and paint peeling

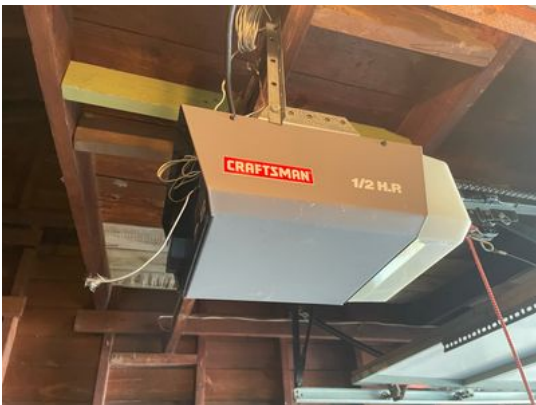
Missing Saftey cables

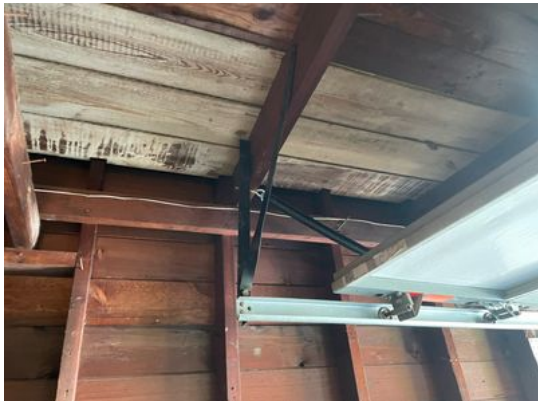
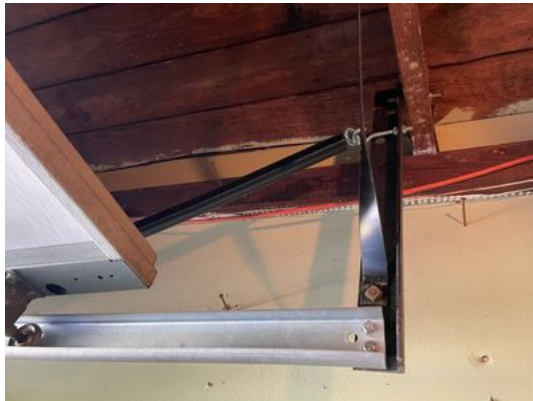
Exposed wiring in garage Recomend evaluation by electrician

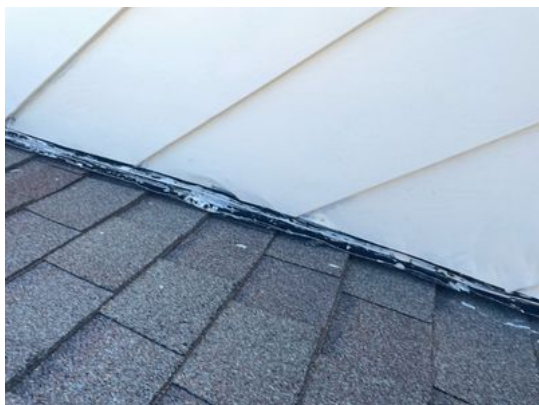
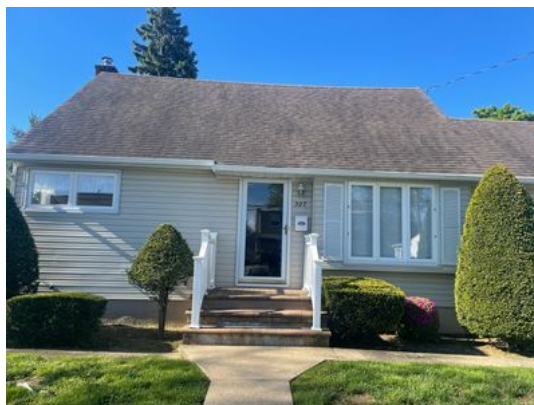
Shows some signs of weathering Recomend moss removal

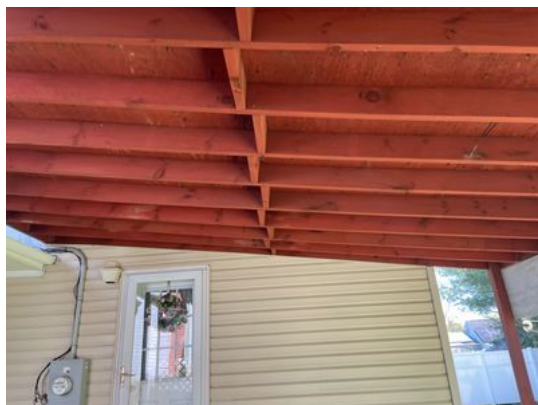
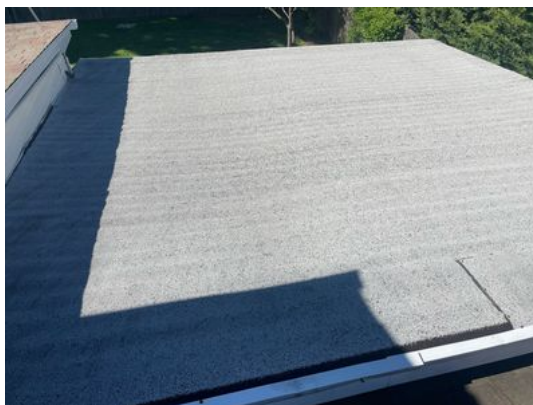
Roof over patio shows signs of sagging, feels spongy and soft, Recomend professional evaluation

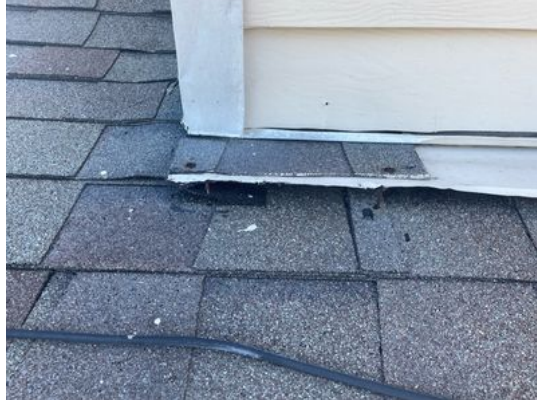
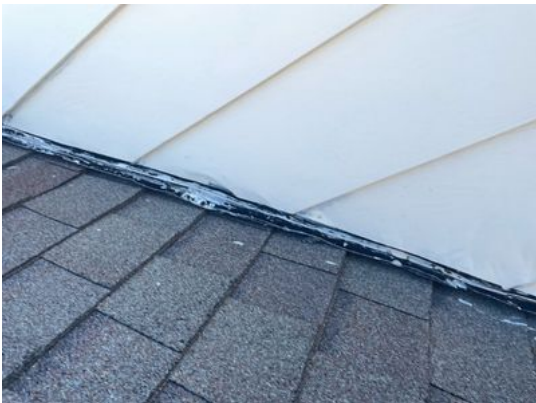
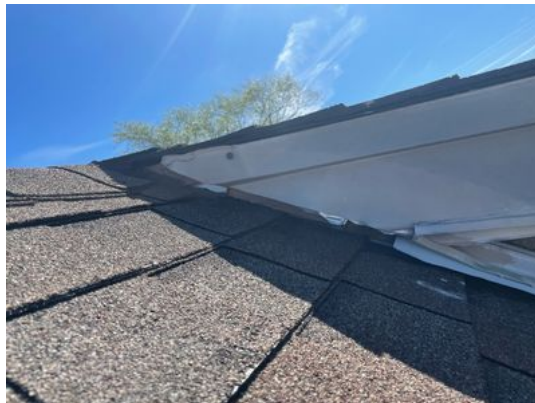
Flashing shows signs of wear

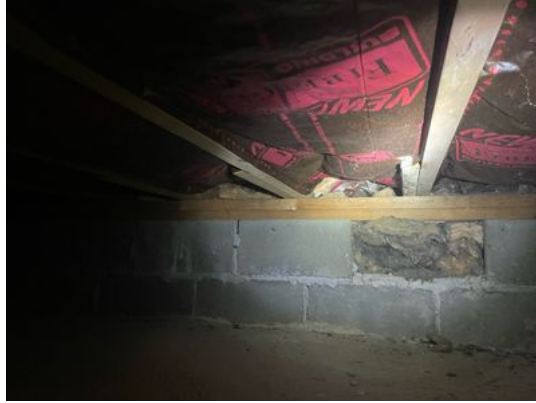
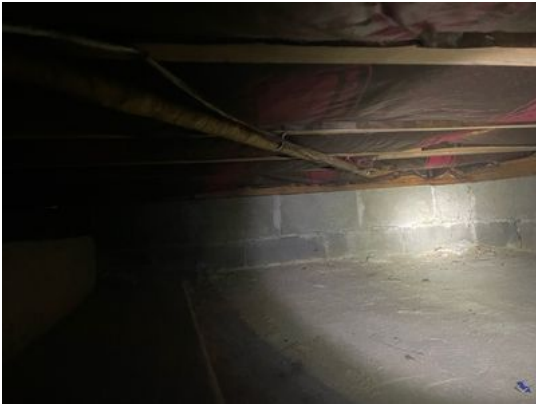
Signs of efflorescence indicating vapor intrusion, Recomend waterproofing treatment by professional

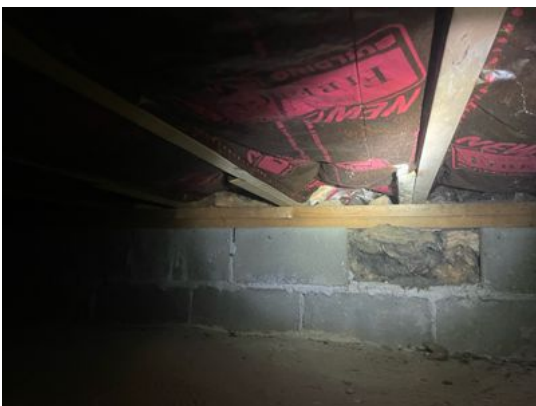
Vent appears to be covered with insulation

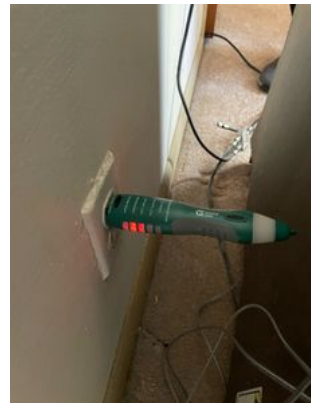
Exterior outlets not operating, Recomend replace with GFCI's.

Outlets in livingroom, down stairs bedrooms, and in basement not grounded Recomend evaluation by licensed eletriction

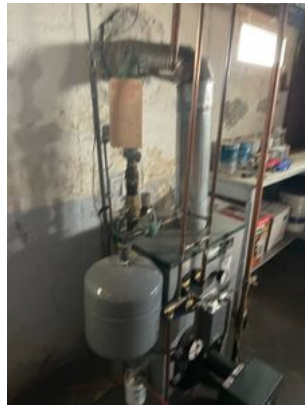
Boilers generally last an average of 15-20 years, this boiler is 22 years old, Recommend having it serviced by a professional for further evaluation

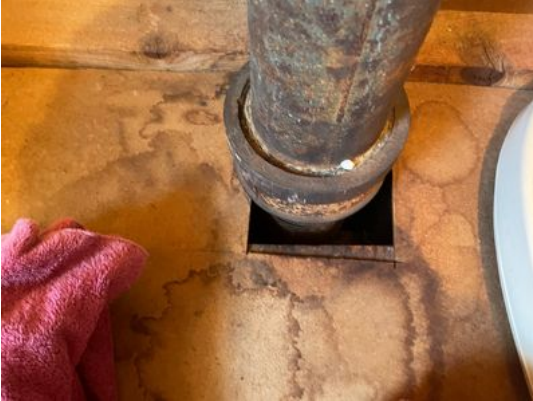
Main vent stack not secure

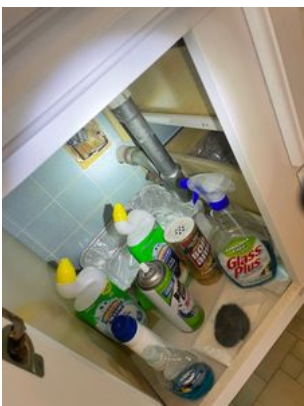
Hole in tile as a result of possible repair work done to hot water line

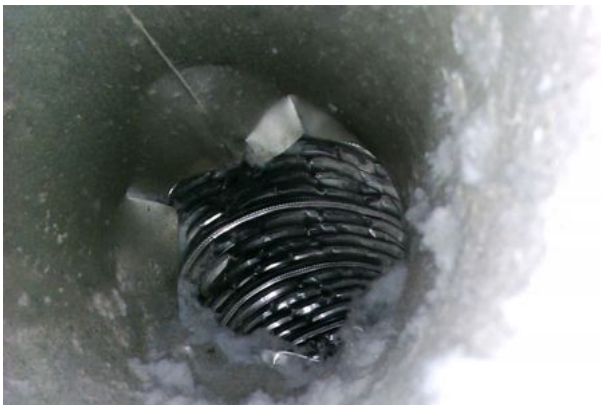
Recomend cleaning dryer vent

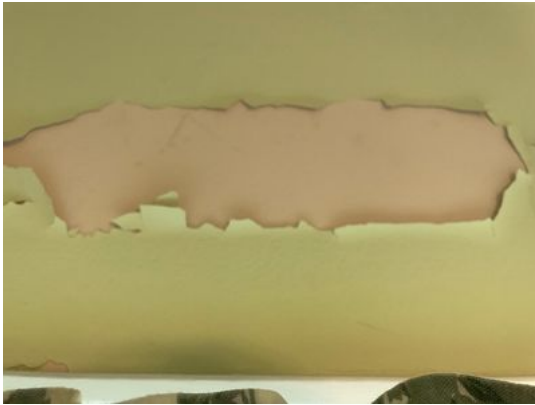
Recomend repaint kitchen walls to prevent further paint chipping
