# Home Inspection Report

227 33rd Street

Lindenhurst, NY 11757

Inspected On Fri, May 5, 2023 at 7:15 AM

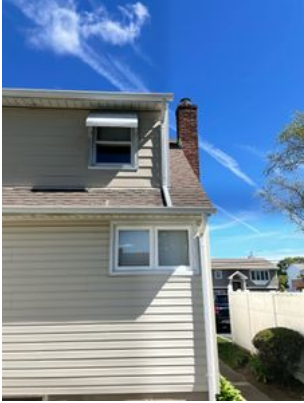
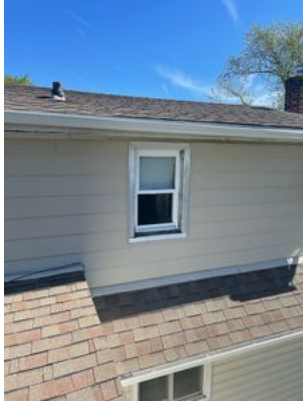
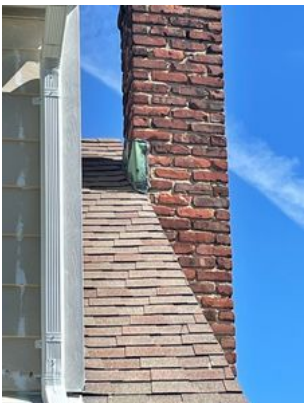
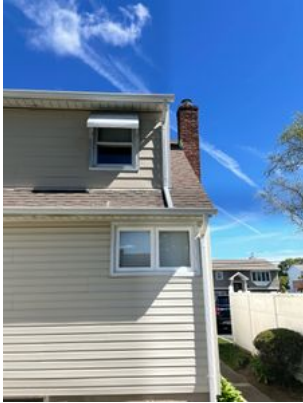
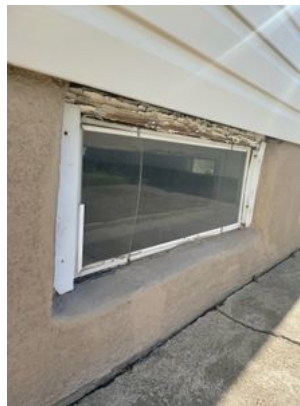
**Comment 3**

**Repair or Replacement Needed**

All window appear operable but in need of screens for child Safety, exterior damage visible on basement windows, upstairs unfinished bathroom window, kitchen south facing window, and north facing livingroom window, trim pulling away in spots and paint peeling

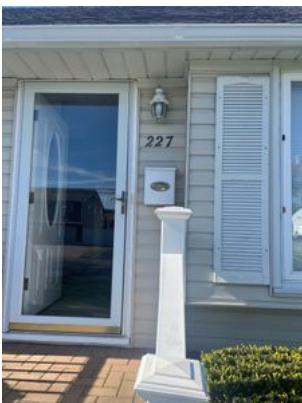
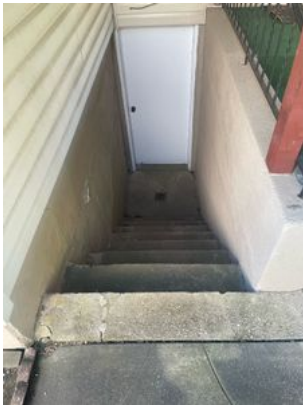
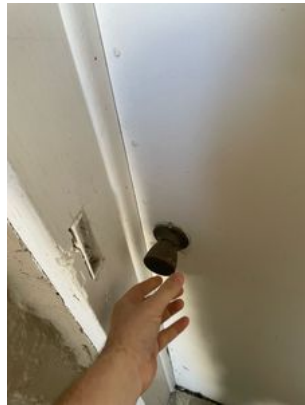
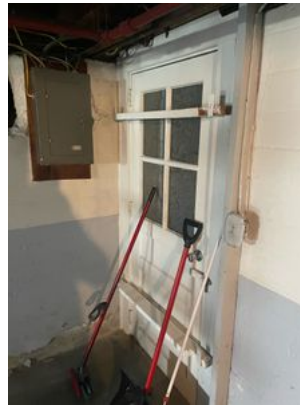
**Comment 4**

**Monitor Condition**

Consider replacement of basement door, interior knob being used, appears to be covered in sheet metal, and not a practical for fire egress.

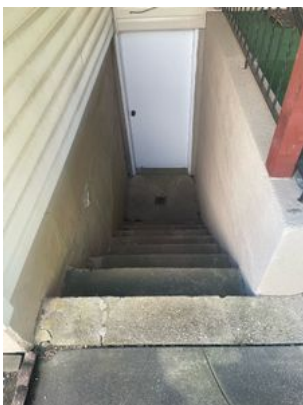
**Safety Concern**

Railing highly recommended

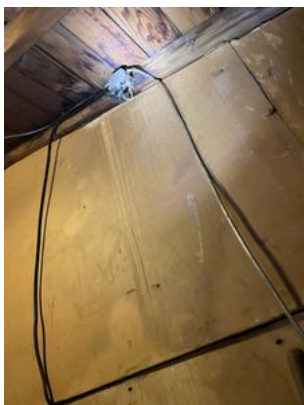
**Repair or Replacement Needed**

Exposed wiring in garage Recomend evaluation by electrician

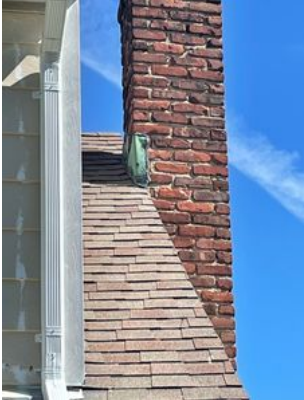
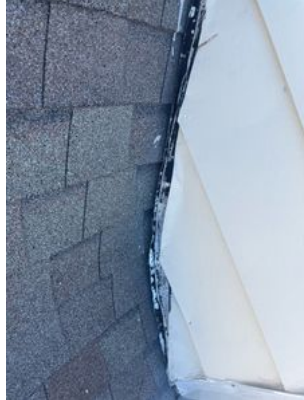
### Comment 11

#### Monitor Condition

Flashing shows signs of wear

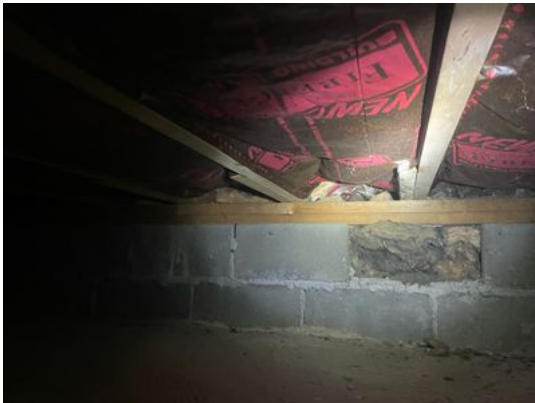
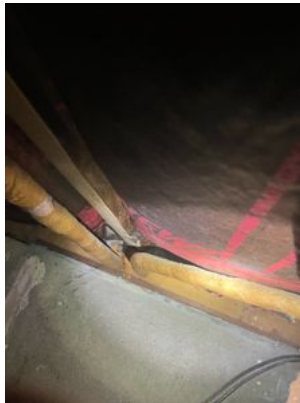
#### Comment 12 Information

No signs of wood destroying organisms

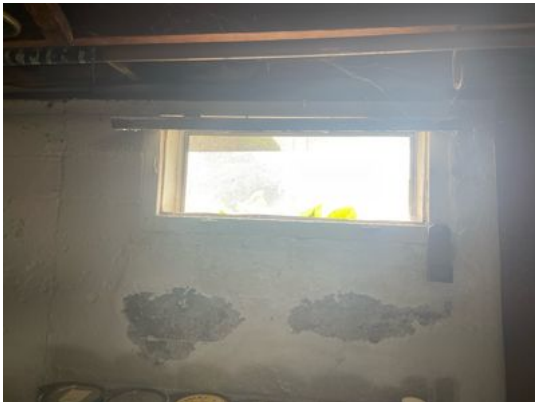
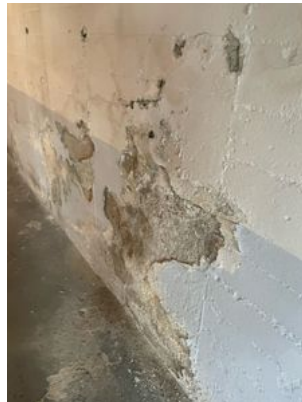
Signs of efflorescence indicating vapor intrusion, Recomend waterproofing treatment by professional

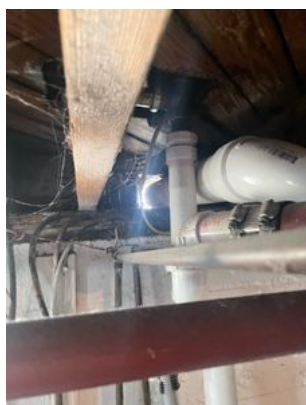
Outside opening above dryer in basement should be sealed

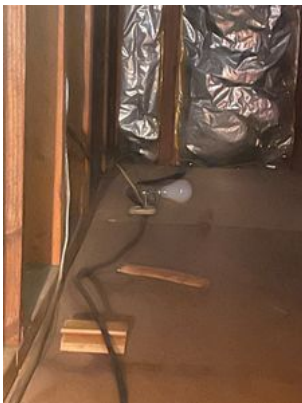
Recomend having light perminatly installed if needed

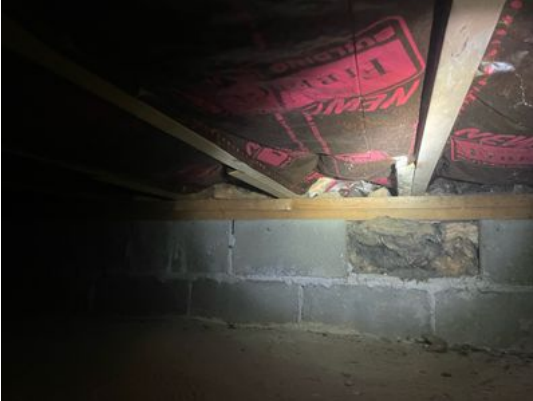
Vent appears to be covered with insulation

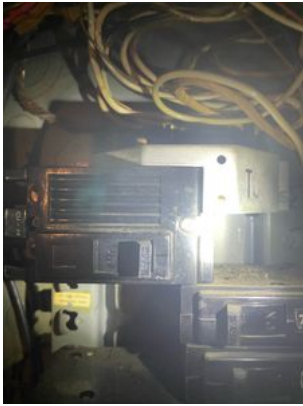
Current amperage 100, Recomend upgrade to 200 amp service

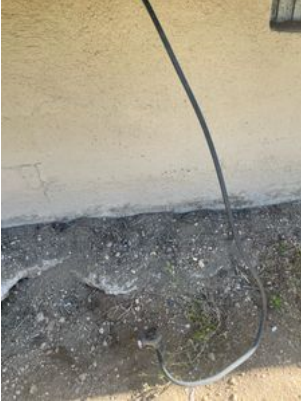
Main ground in rear of house

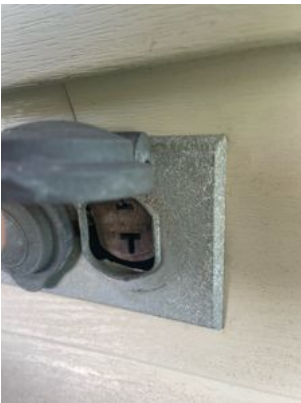
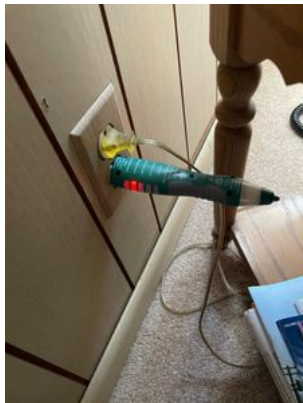
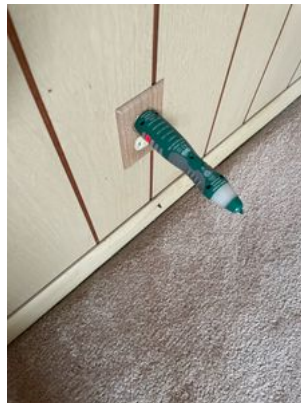
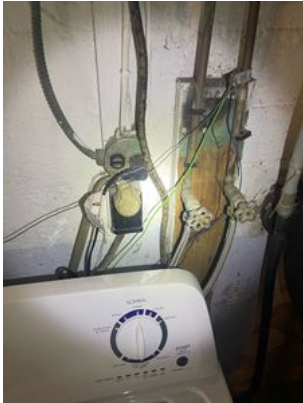
Exterior outlets not operating, Recomend replace with GFCI's.

Outlets in livingroom, down stairs bedrooms, and in basement not grounded Recomend evaluation by licensed eletriction

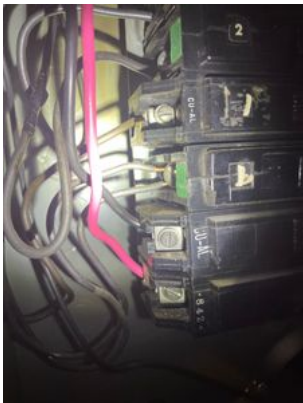
Double tap on breaker, Recommend evaluation by electrician

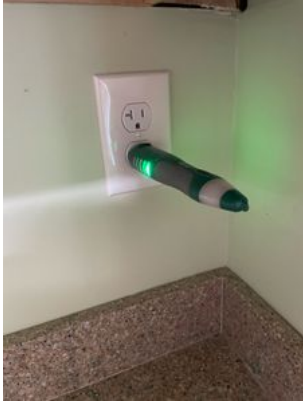
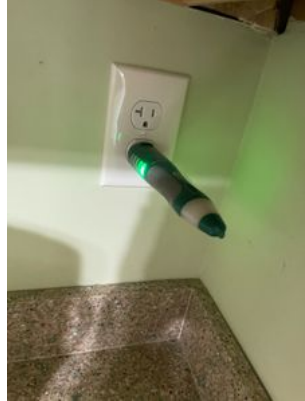
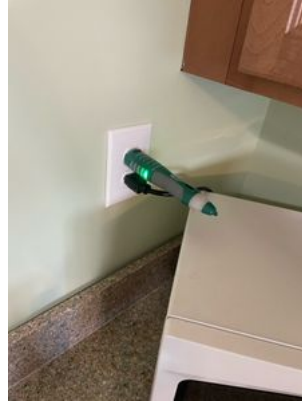
Recomend GFCI outlets in kitchen

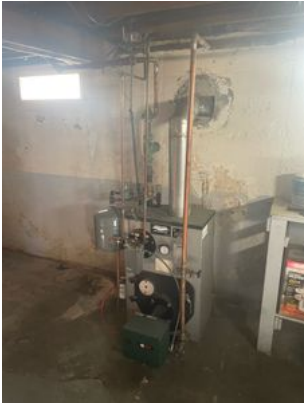
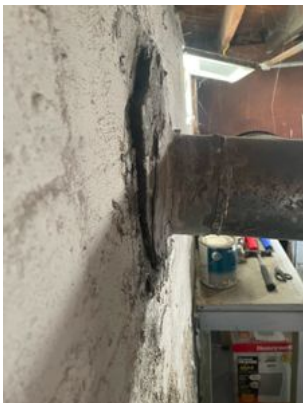
**Comment 23**

**Safety Concern**

Recomend boiler exhaust pipe sealed by professional

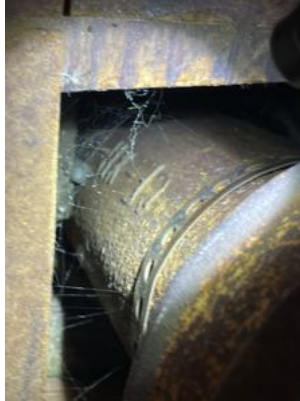
**Repair or Replacement Needed**

Main vent stack not secure

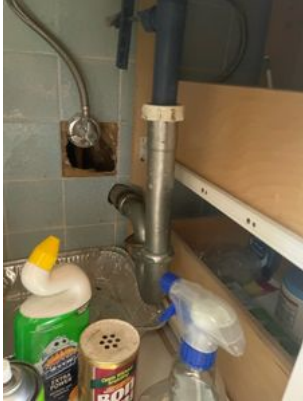
**Comment 27**

**Repair or Replacement Needed**

Hole in tile as a result of possible repair work done to hot water line

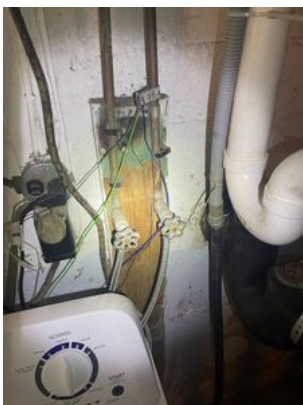
#### Monitor Condition

Recomend Gfci behind washing machine

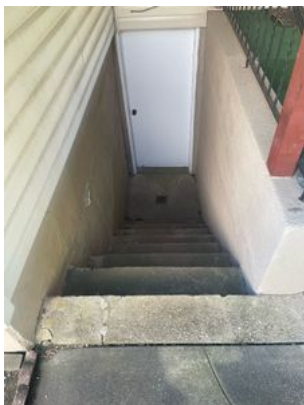
#### Exterior: Railings

Railing highly recommended

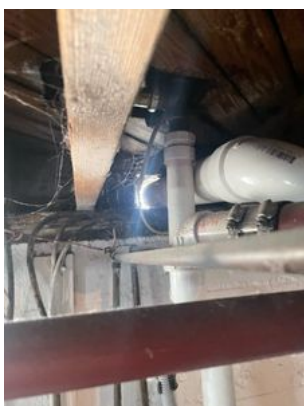
#### Structure: Signs of Water Penetration

Outside opening above dryer in basement should be sealed

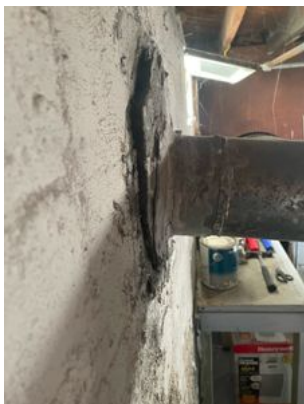
### HVAC: Heating: Type of Equipment

Recomend boiler exhaust pipe sealed by professional

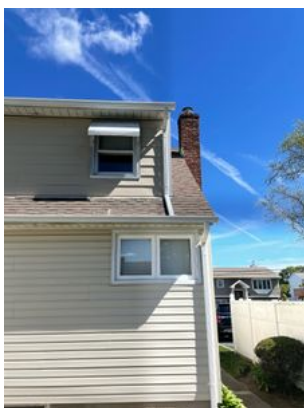
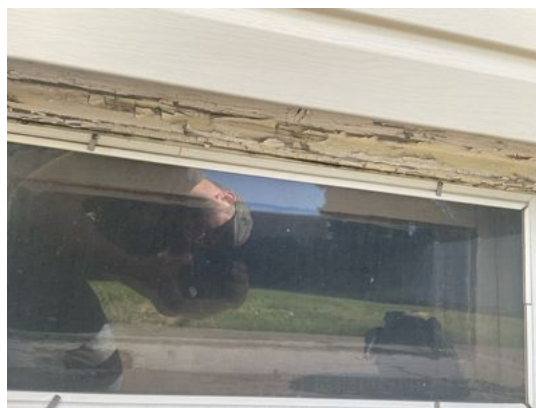
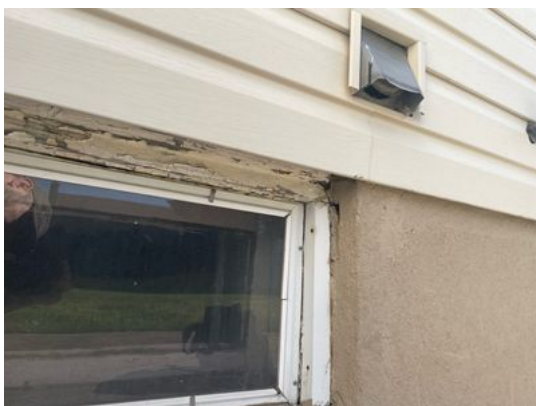
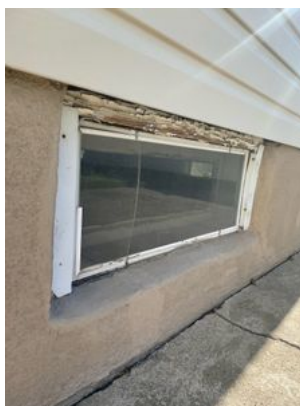
#### Exterior: Windows

All window appear operable but in need of screens for child Saftey, exterior damage visible on basement windows, upsairs unfinished bathroom window, kitchen south facing window, and north facing livingroom window, trim pulling away in spots and paint peeling

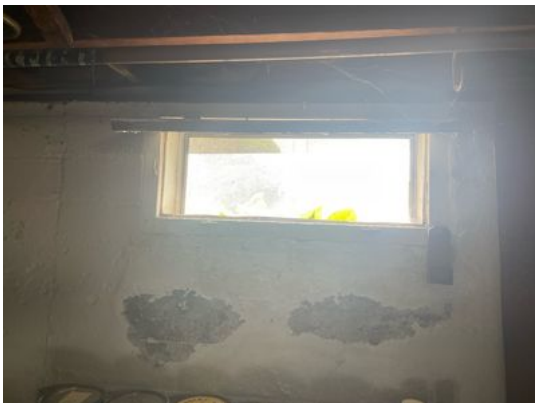
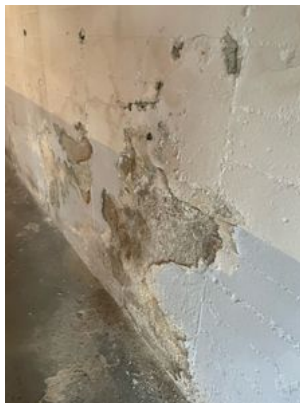
### Structure: Foundation Material

Signs of efflorescence indicating vapor intrusion, Recommend waterproofing treatment by professional

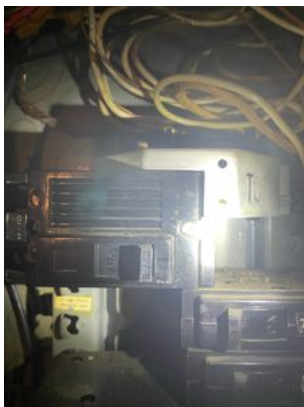
### Electrical: Service Amperage

Current amperage 100, Recomend upgrade to 200 amp service

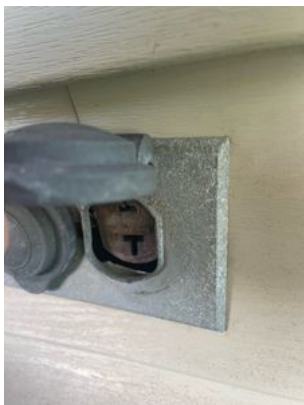
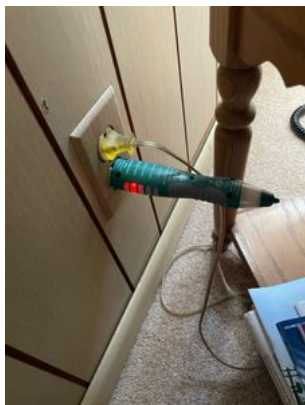
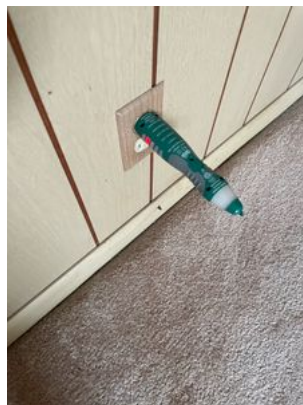
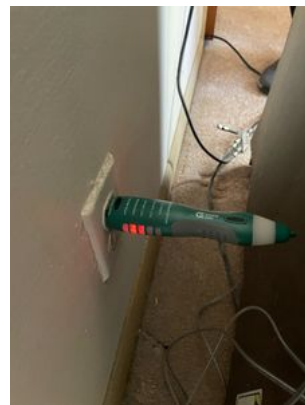
### Electrical: Branch Circuit Wiring

Exterior outlets not operating, Recomend replace with GFCI's.

Outlets in livingroom, down stairs bedrooms, and in basement not grounded Recomend evaluation by licensed eletriction

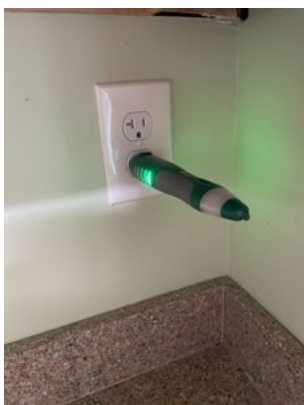
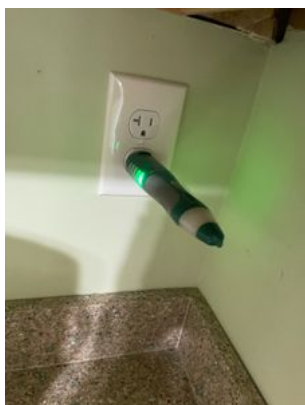
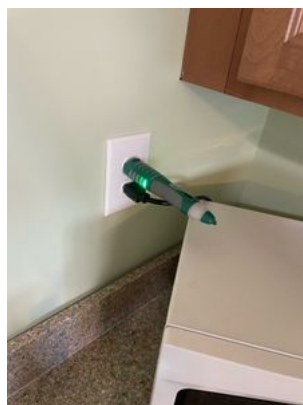
### Electrical: GFCI/AFCI Breakers

Recommend GFCI outlets in kitchen

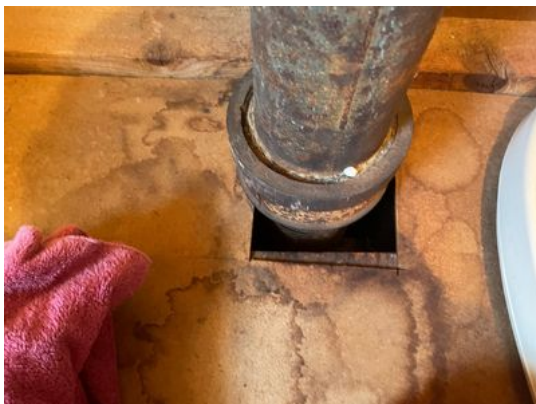
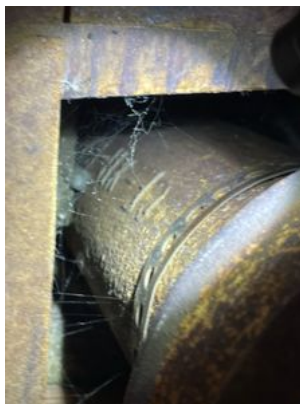
### Plumbing: Waste Pipe Material

Main vent stack not secure

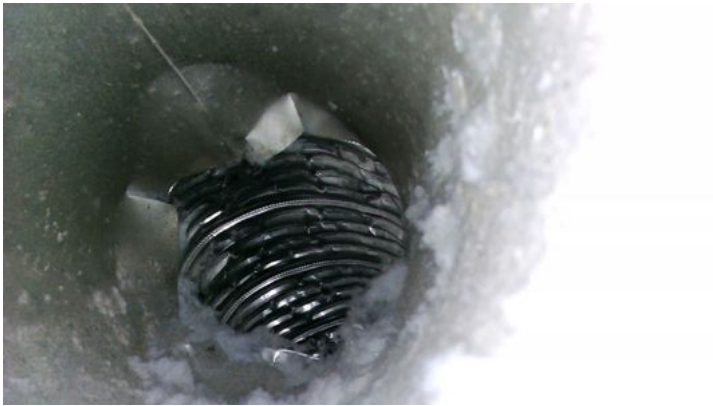
**Laundry: Dryer Venting**

Recomend cleaning dryer vent

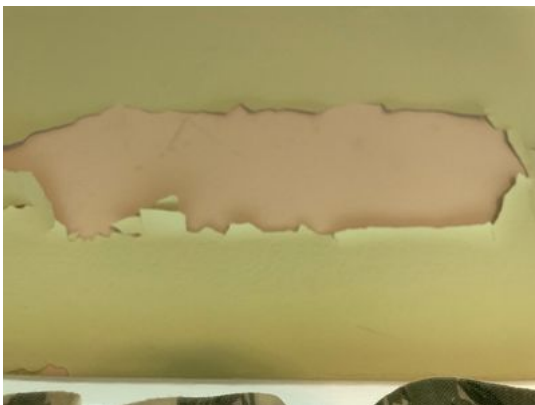
**Interior: Walls**

Recomend repaint kitchen walls to prevent further paint chipping
